3 MOTOR GRADER TEST 3

Caterpillar Grader - Model 12

San Bernardino National Forest

January 23 - March 15, 1950

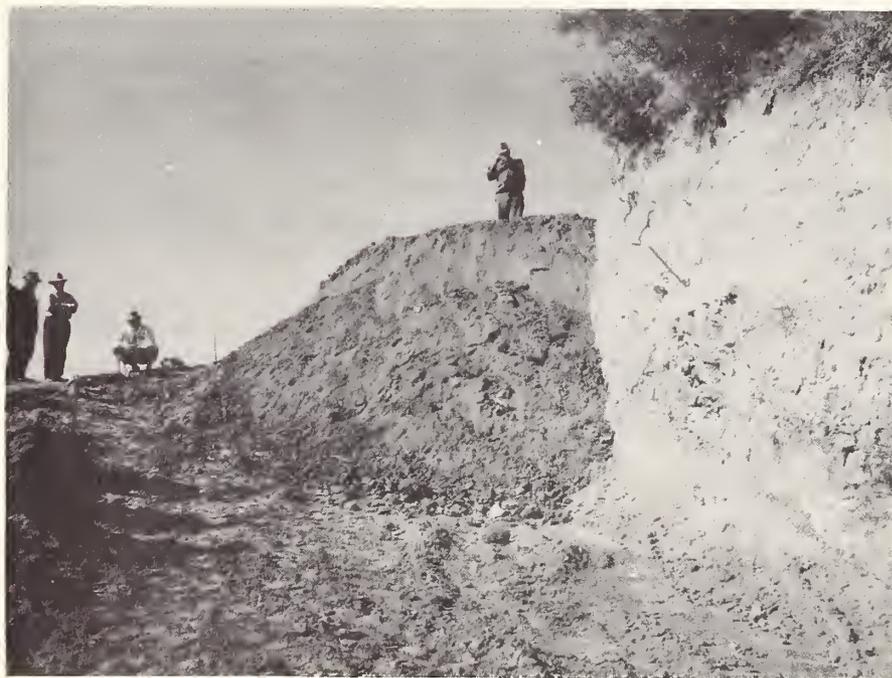
Fig. 4. Test Slide

A slide of designed shape comprising approximately 125 cubic yards was built by a tractor, avoiding compaction of material as much as possible. Dirt was allowed to accumulate on the down-grade (or approach) side at its natural angle of repose, which was approximately 70%. Boundaries were established by means of stakes simulating a perpendicular bank beyond which a wheel under power was not permitted. Refer to Fig. 4.

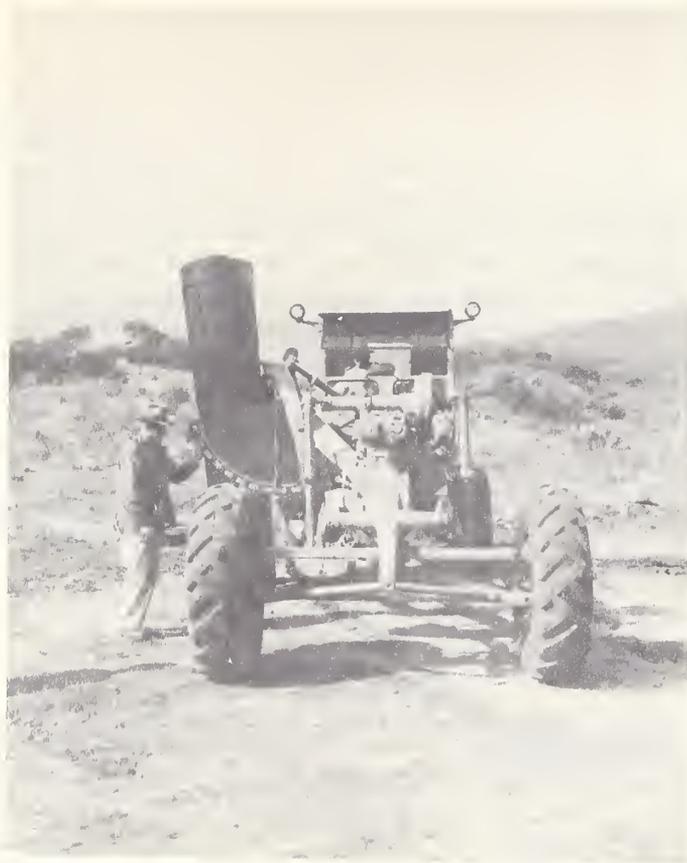
Figure 7. Bank Slope Angle -  $\frac{1}{4}$ :1

A re-run of test of Bank Slope Blade positions was made with all machines, to obtain more accurate data. In the meantime, a bulldozer attachment had been installed on the Cat #12 and it was decided to attempt to attain test slope angles with this attachment intact. A maximum of only 63° was attainable. Interference between the circle drawbar, scarifier linkage, and bulldozer attaching frame prevented the attainment of over 63°. Previous bank slope tests of the Cat #12, without bulldozer attachment, proved the 76° angle could be attained without difficulty. Refer to photographs, Figures 7 and 8.

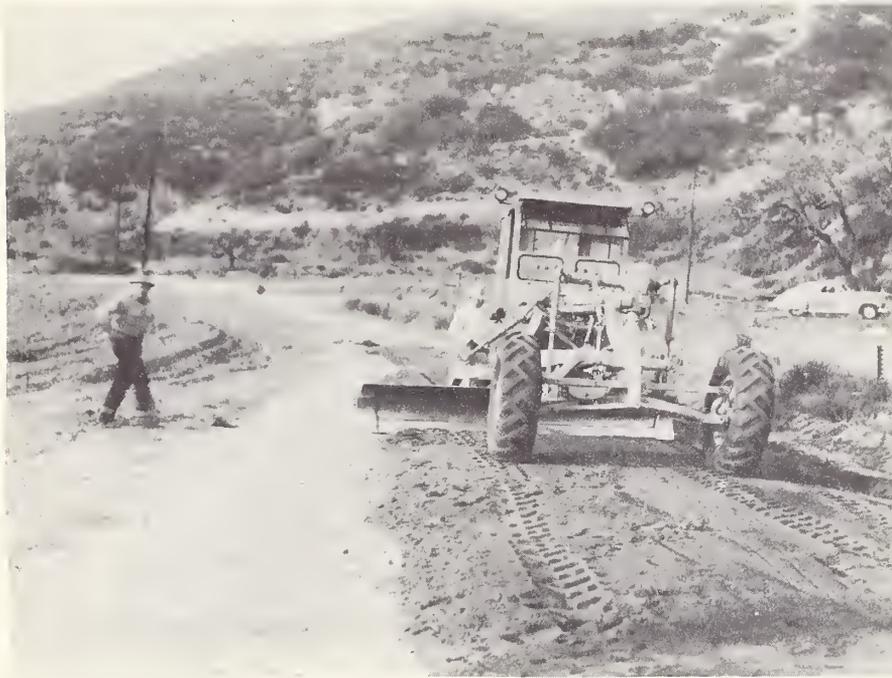
Figure 9. Blade Side Shift

The time required to offset the Cat #12 blade on the circle was not obtained with accuracy. Difficulty was encountered in the first attempt due to a binding condition. This was conceded to be caused by heavy paint on the blade shift sliding surfaces, as shifting was accomplished more freely after paint was removed. However, due to the tendency to bind, and uncertainty of positive lock position, this particular method as used on the Cat #12 was considered by test observers to be less desirable than the power ram or unbolt-rebolt methods used on other units. Photograph, Figure 9, shows blade side shifted on circle.

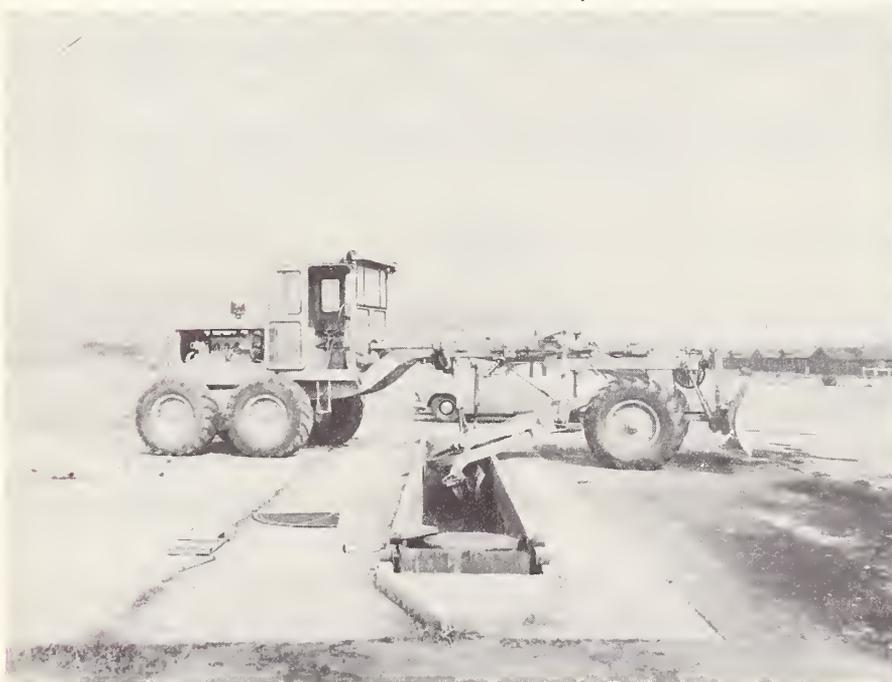
Figure 10. Maximum Drop Below Ground

- E. Blade Lift. The maximum lift of blade above ground, drop below ground, angle of lift right and left with blade centered, and the clearance between blade cutting edge and bottom of circle are given in the comparison Table V.

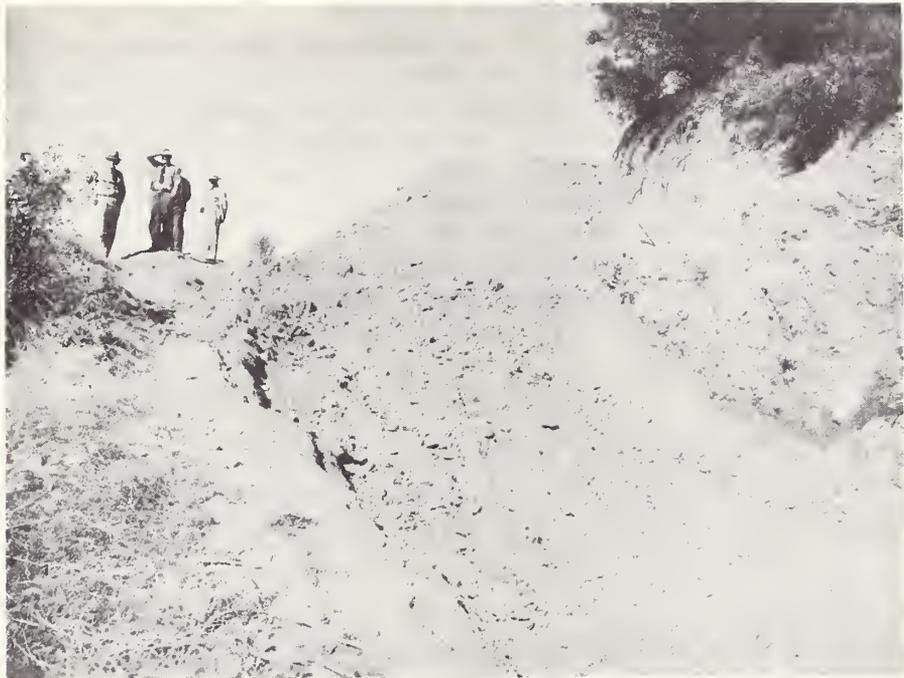
Figure 16. Slide - Before Test

Figures 16 and 17 show the slide before and while being worked on by the Cat #12.

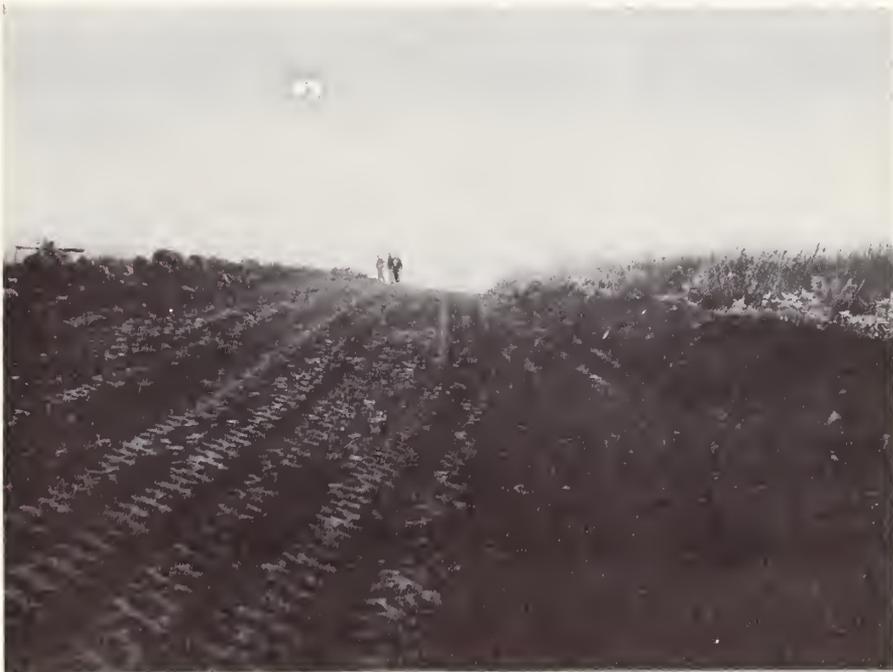
It was recognized that this ditching test was most severe and beyond the normal operations encountered or anticipated. Refer to photograph, Figure 18. It was, in effect, an accelerated aging test to determine the ability of the graders. It was the expressed opinion of observers that the Cat #12 and one of the other graders were driven harder by the operators in this test than any of the other units. This undoubtedly contributed to the record of minimum time. In spite of this, however, no detrimental effects to the machine were noted. This was considered by observers to be complimentary to the design and structural adequacy of the Cat #12. Refer to Figure 19 for the finished ditch.

Figure 19. Finished ditch.

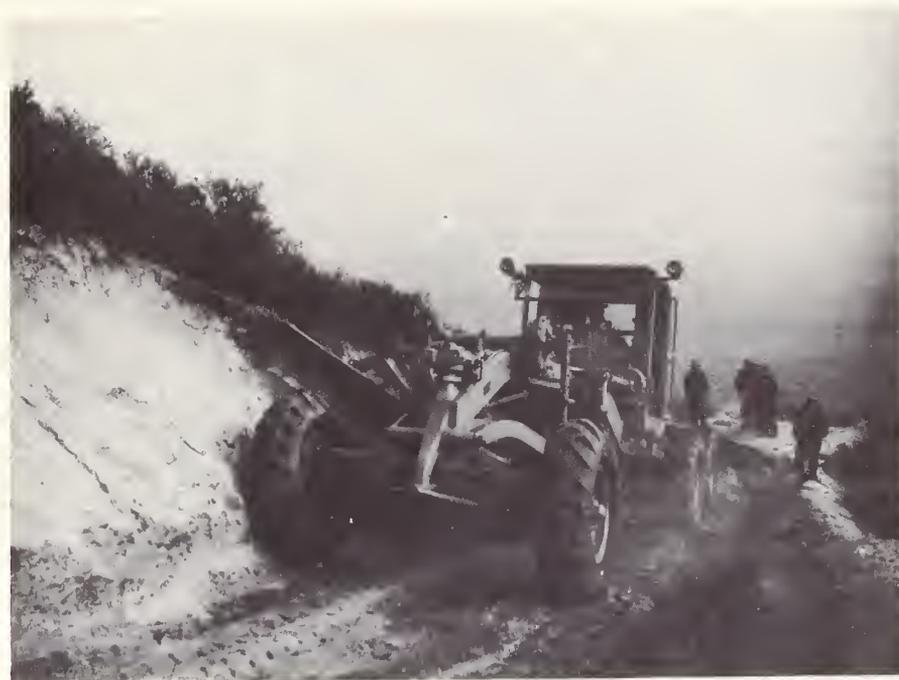
Figure 20. Bank Sloping

It was conceded by test observers that all tandem graders would have some difficulty in bank sloping short radius inside curves. On outside curves and tangents this difficulty was not apparent. Refer to photograph, Figures 20 and 21.

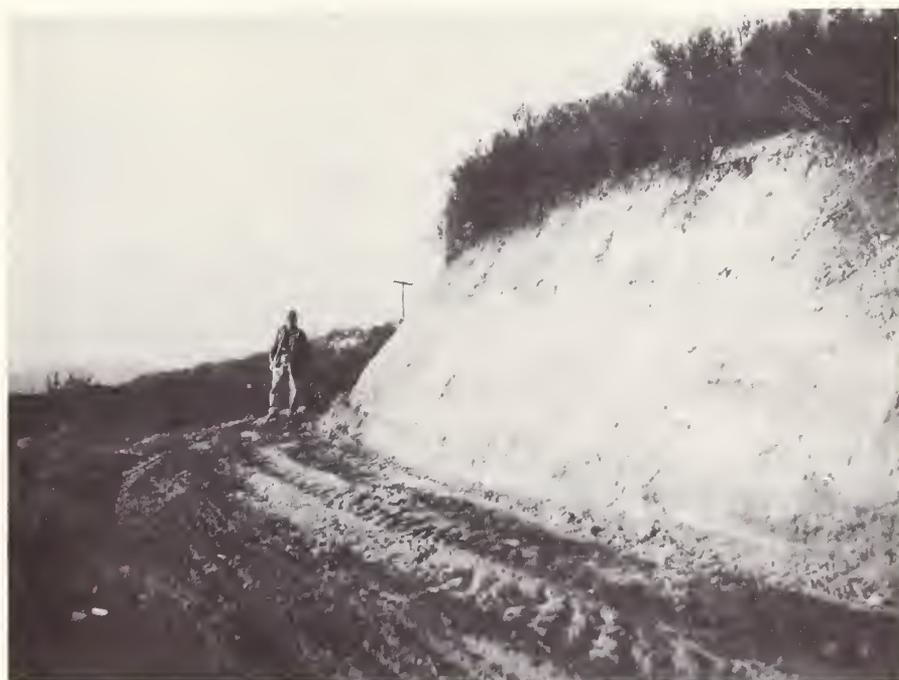
Figure 21. Bank Sloping - Outside curve.

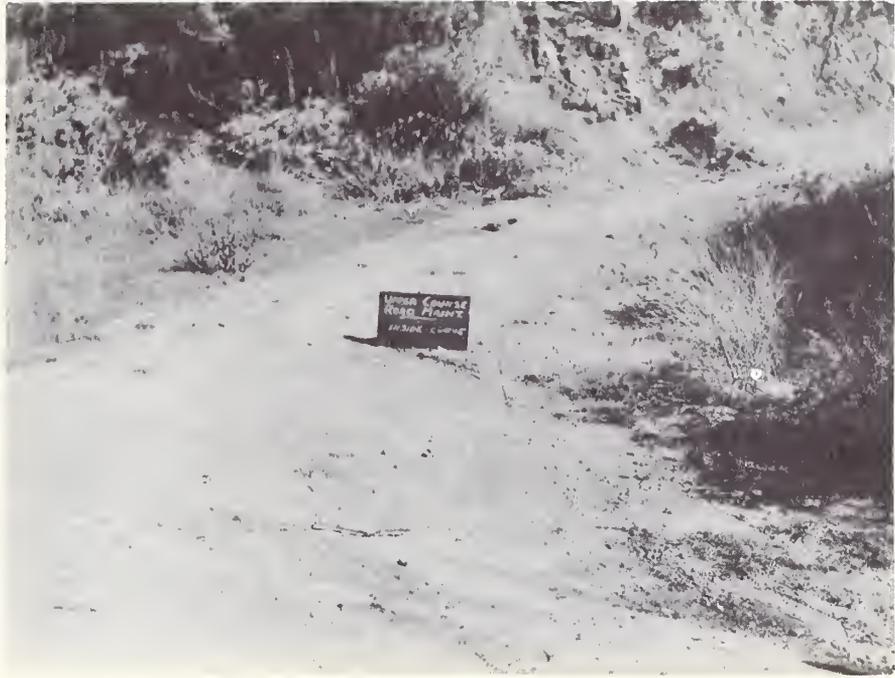
Many photographs were taken of the test in an effort to record the operation. These were studied during preparation of the report. Four which were considered pertinent are shown as Figures 22 to 25.

Figure 22. Typical Section Prior to Grading.

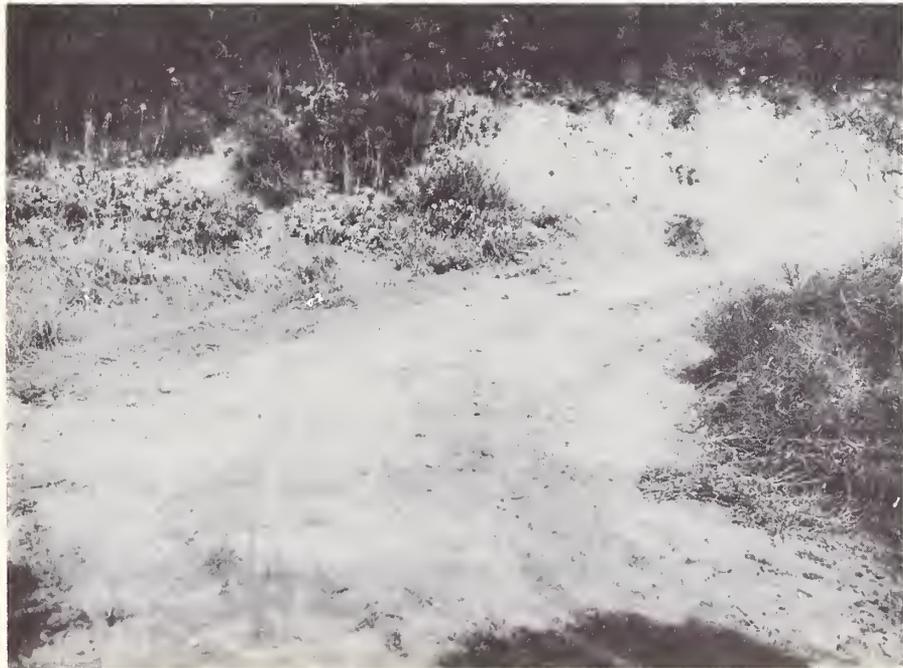
Figure 23. Same Section after Road Grading.

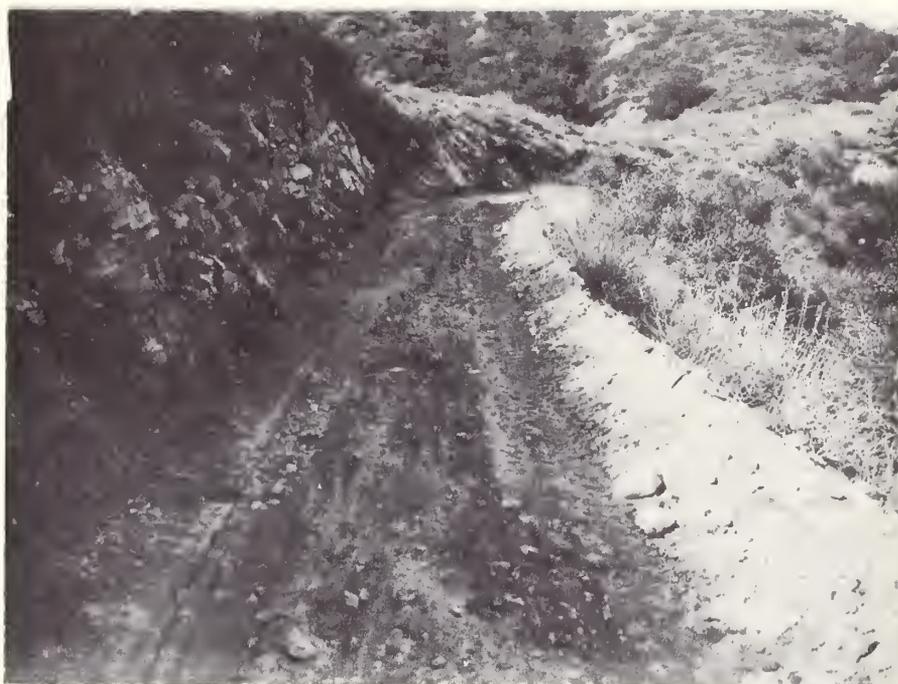
Figure 24. Completed Section of Road Grading

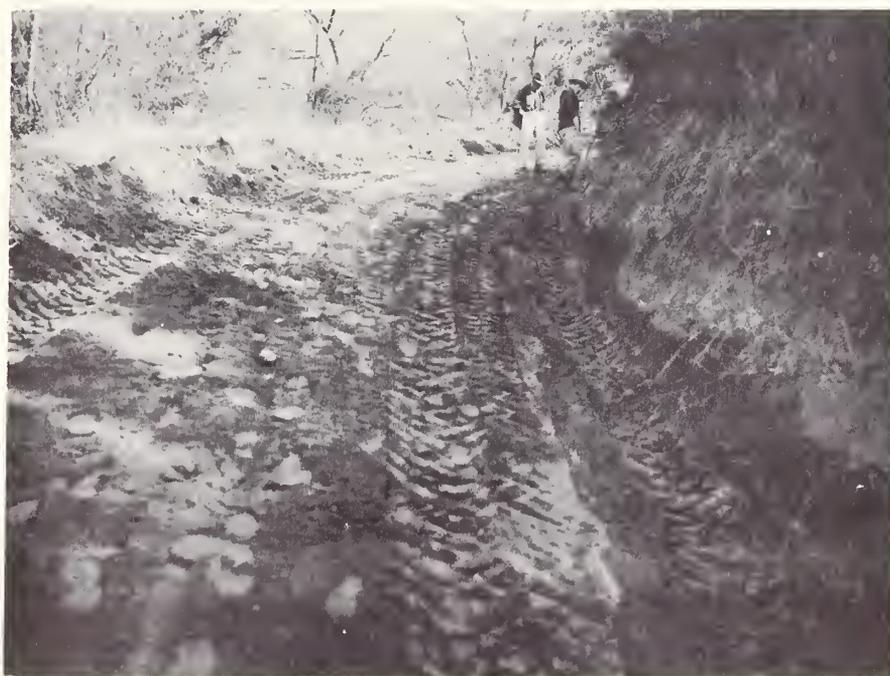
Figure 25. Completed Section of Road Grading.

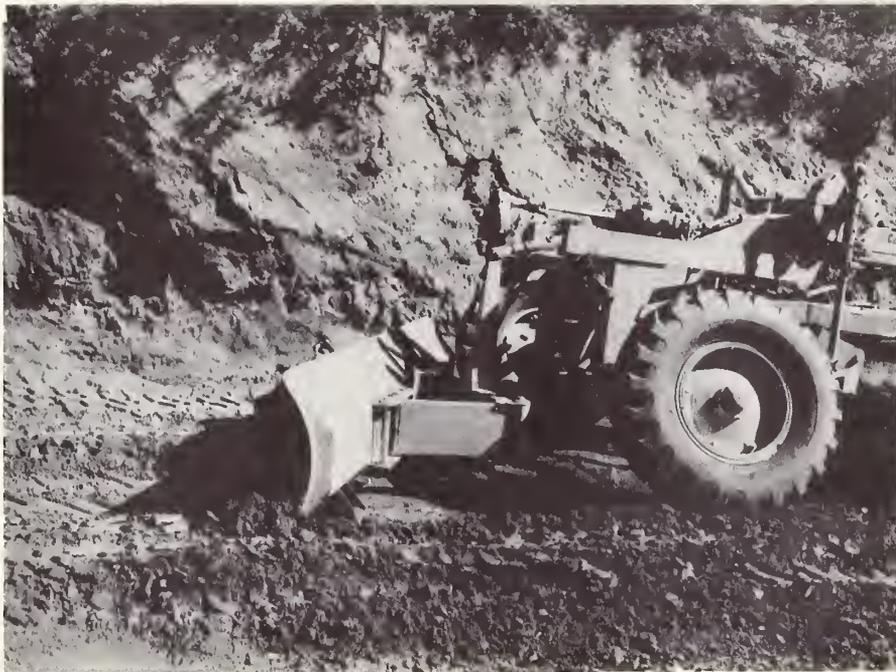
The Cat #12 dozer and attaching assembly is comprised of extensive frame work, shafts, gear box, linkage, shaft pins, etc. which was the cause of the longer installation time. The other dozer unit was installed by simple attachment at three points. However, once installed blades only could be removed or replaced in comparable time. Photographs Figures 26 and 27 show Cat Dozer Blade installation.

Figure 26. Caterpillar Dozer Attachment.

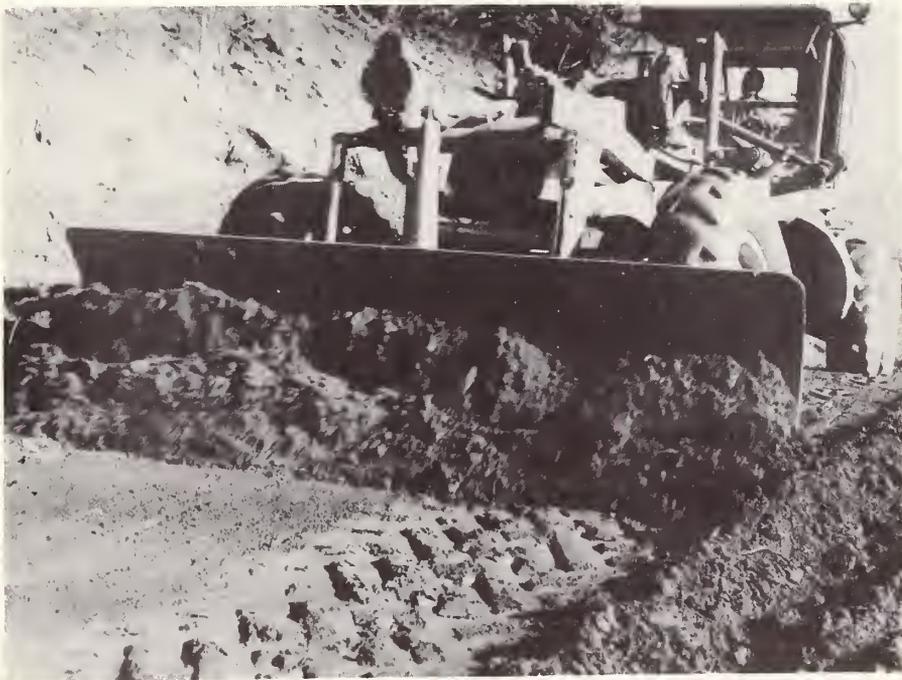
Figure 27. Dozer in Operation.

When the bulldozer was installed the operator's forward visibility was decreased by blade and blade operating mechanism.
